Manhole Inspection Summary

Manhole # S47GG_034MH

Record Plat: **47GG** Node: **034** Status: **Found**

Insp Date: **2/24/10 2:26 PM**

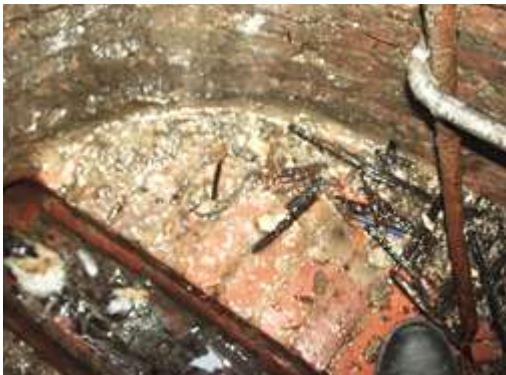
Defect 3

Condition: ☐ Sound ☐ Cracked ☐ Root Intrusion ☐ Deteriorated ☒ **Leaks** ☒ **Debris**

debris

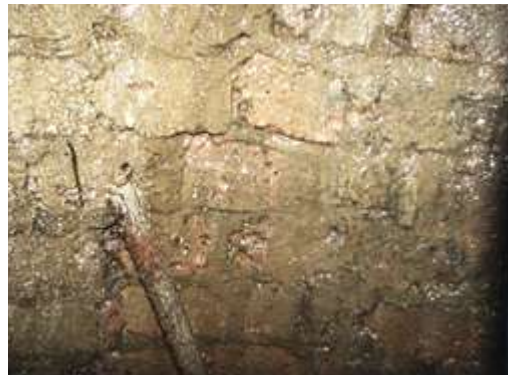
Defect 2

Infiltration: ☐ None ☐ Joint ☐ Cracks ☒ **Mortar** ☐ Roots ☐ Wall

infiltration

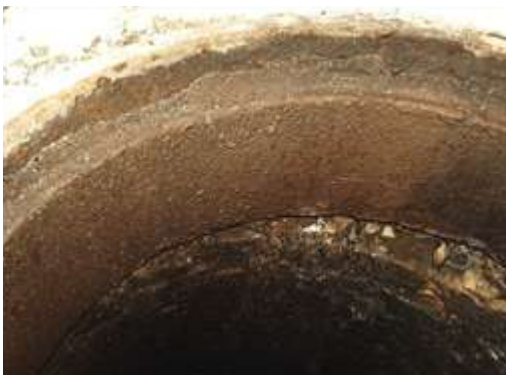
Defect 1

Frame Offset: **1** (in.) Condition: ☐ Sound ☐ Cracked ☒ **Leaks**

frame

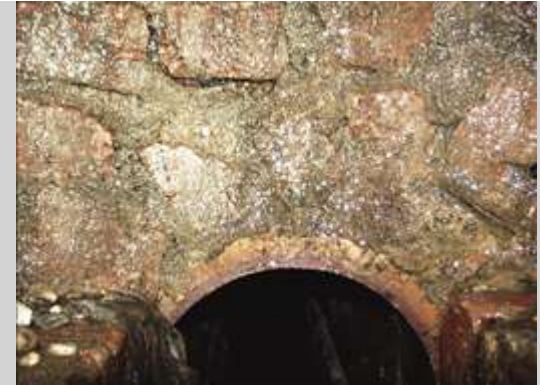
12 O'Clock Outflow

8 in. Circular Gravity Sewer
Pipe Out @ 12 O'Clock

Pipe Height: **12** (in.) Rod and Bar (Angled)
Pipe Material: **Clay** ☐ Pipe Lined
Invert Depth: **6.50** (ft.) Flow Characteristics: **Slow**
Deposits: ☒ None ☐ Mud ☐ Sludge ☐ Debris ☐ Grease
Silt Depth: (in.) Deposits Extent:
Infiltration: **None** Pipe Seal Cond: **Sound**

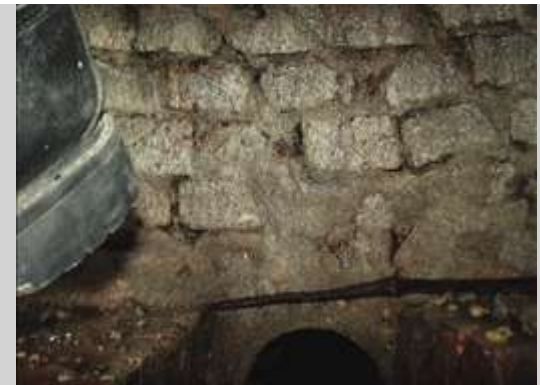
6 O'Clock Inflow

6 in. Circular Gravity Sewer
Pipe In @ 6 O'Clock

Pipe Height: **9.6** (in.) Rod and Bar (Angled)
Pipe Material: **Clay** ☐ Pipe Lined
Invert Depth: **6.50** (ft.) Flow Characteristics: **Slow**
Deposits: ☒ None ☐ Mud ☐ Sludge ☐ Debris ☐ Grease
Silt Depth: (in.) Deposits Extent:
Infiltration: **None** Pipe Seal Cond: **Sound**
